SERVICE BULLETIN AMATEUR RADIO

SUBJECT	DATE
TS-950SD LOW VS-2 AUDIO	01/12/90

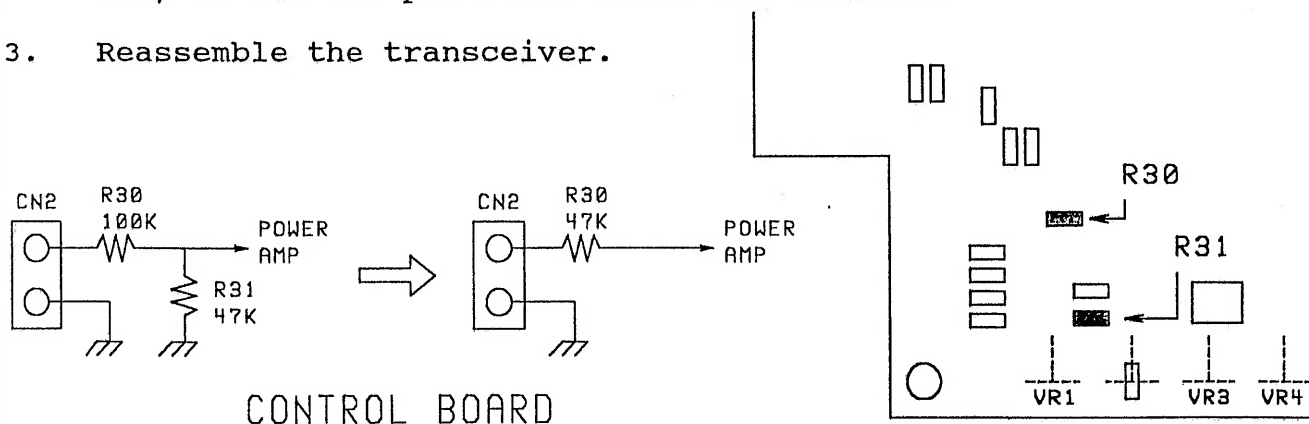
Early TS-950S Digital transceivers will not produce sufficient audio from the optional VS-2 voice synthesizer. The following modification will correct this condition.

THIS WORK WILL BE DONE ON THE FOIL SIDE OF CONTROL BOARD A/3.

1. Desolder and discard chip resistors R30 and R31.
2. Install a 47K ohm chip resistor in place of R30. Do not use R31 (47K ohm) in the R30 position. Use a new resistor.
3. Reassemble the transceiver.
